**AIR FORCE FLIGHT DYNAMICS LABORATORY  
DIRECTOR OF LABORATORIES  
AIR FORCE SYSTEMS COMMAND  
WRIGHT PATTERSON AIR FORCE BASE OHIO**

**Crack Propagation Test Results for Variable  
Amplitude Spectrum Loading in Surface Flawed D6ac Steel**

Technical Memorandum FBR-71-2

February 1971

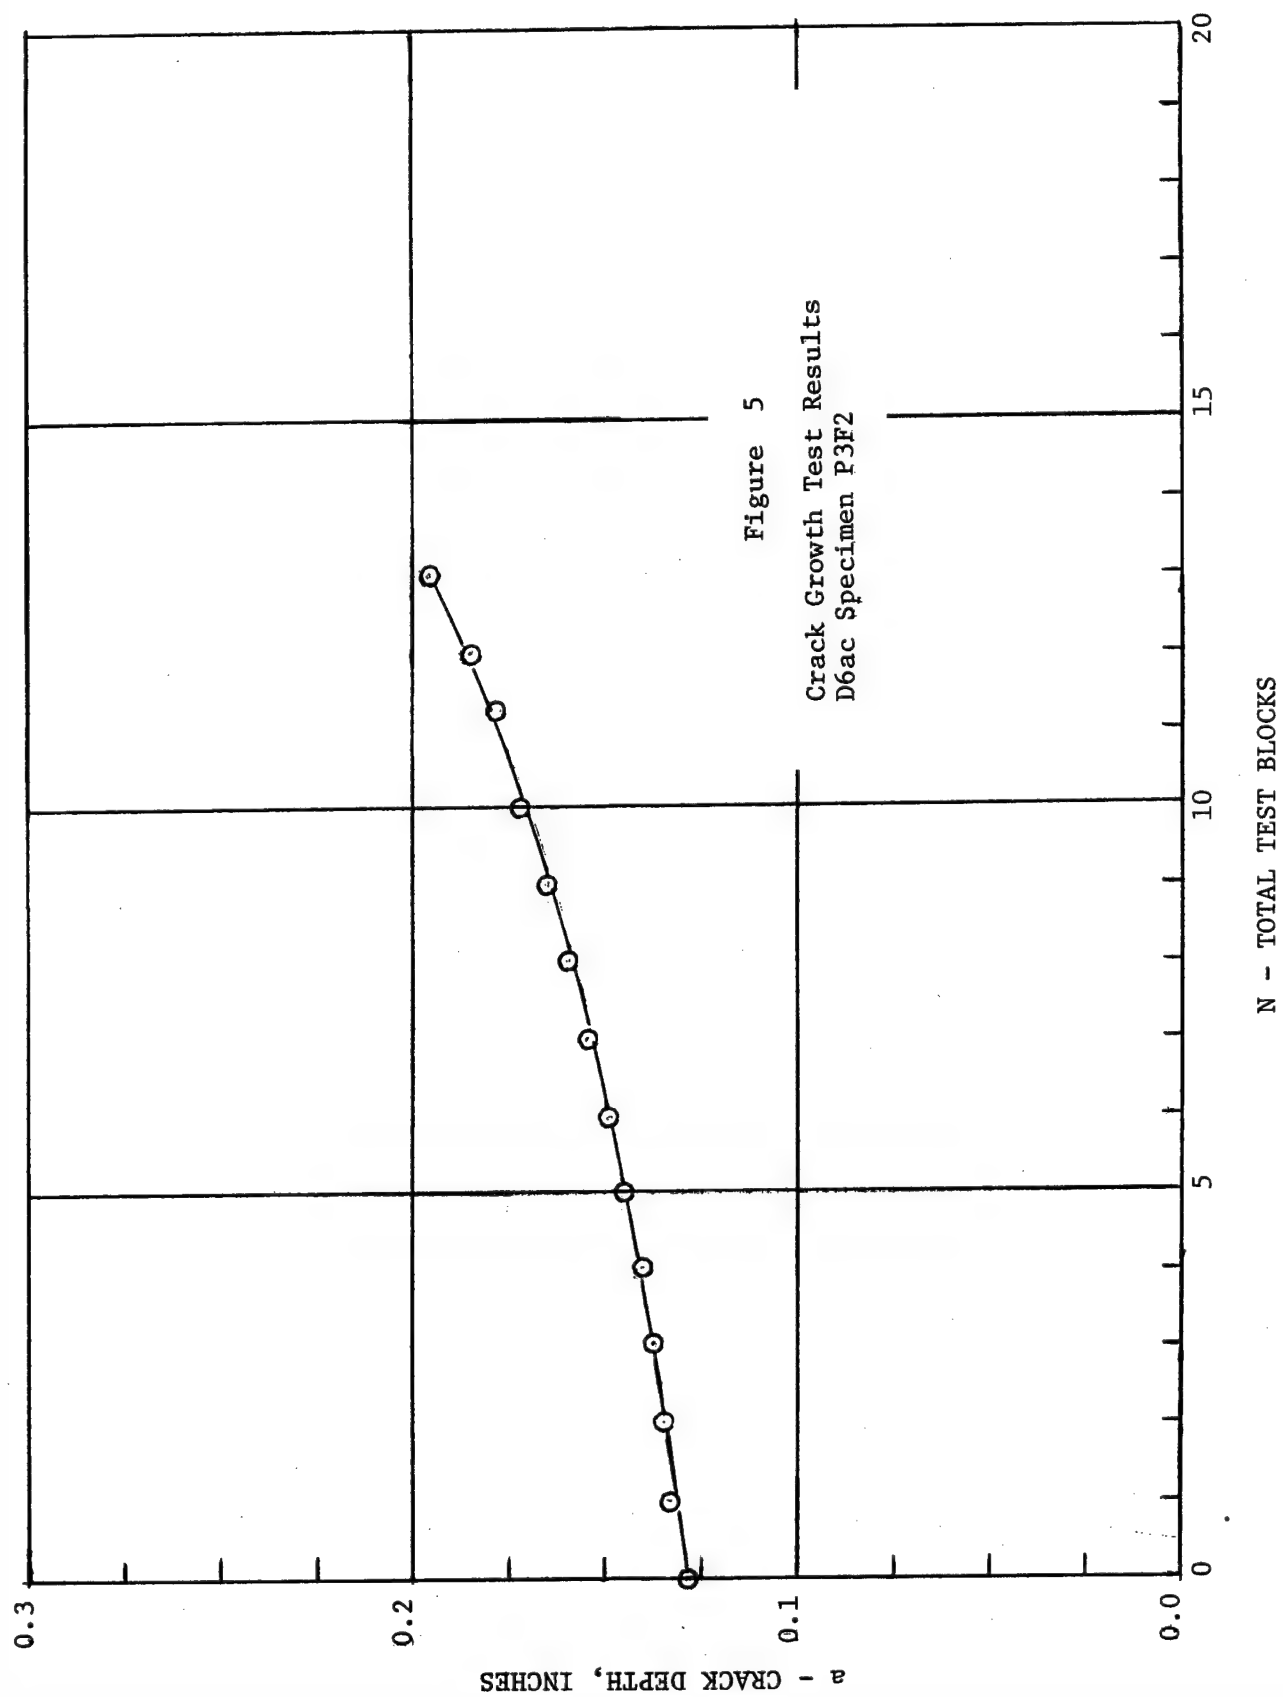
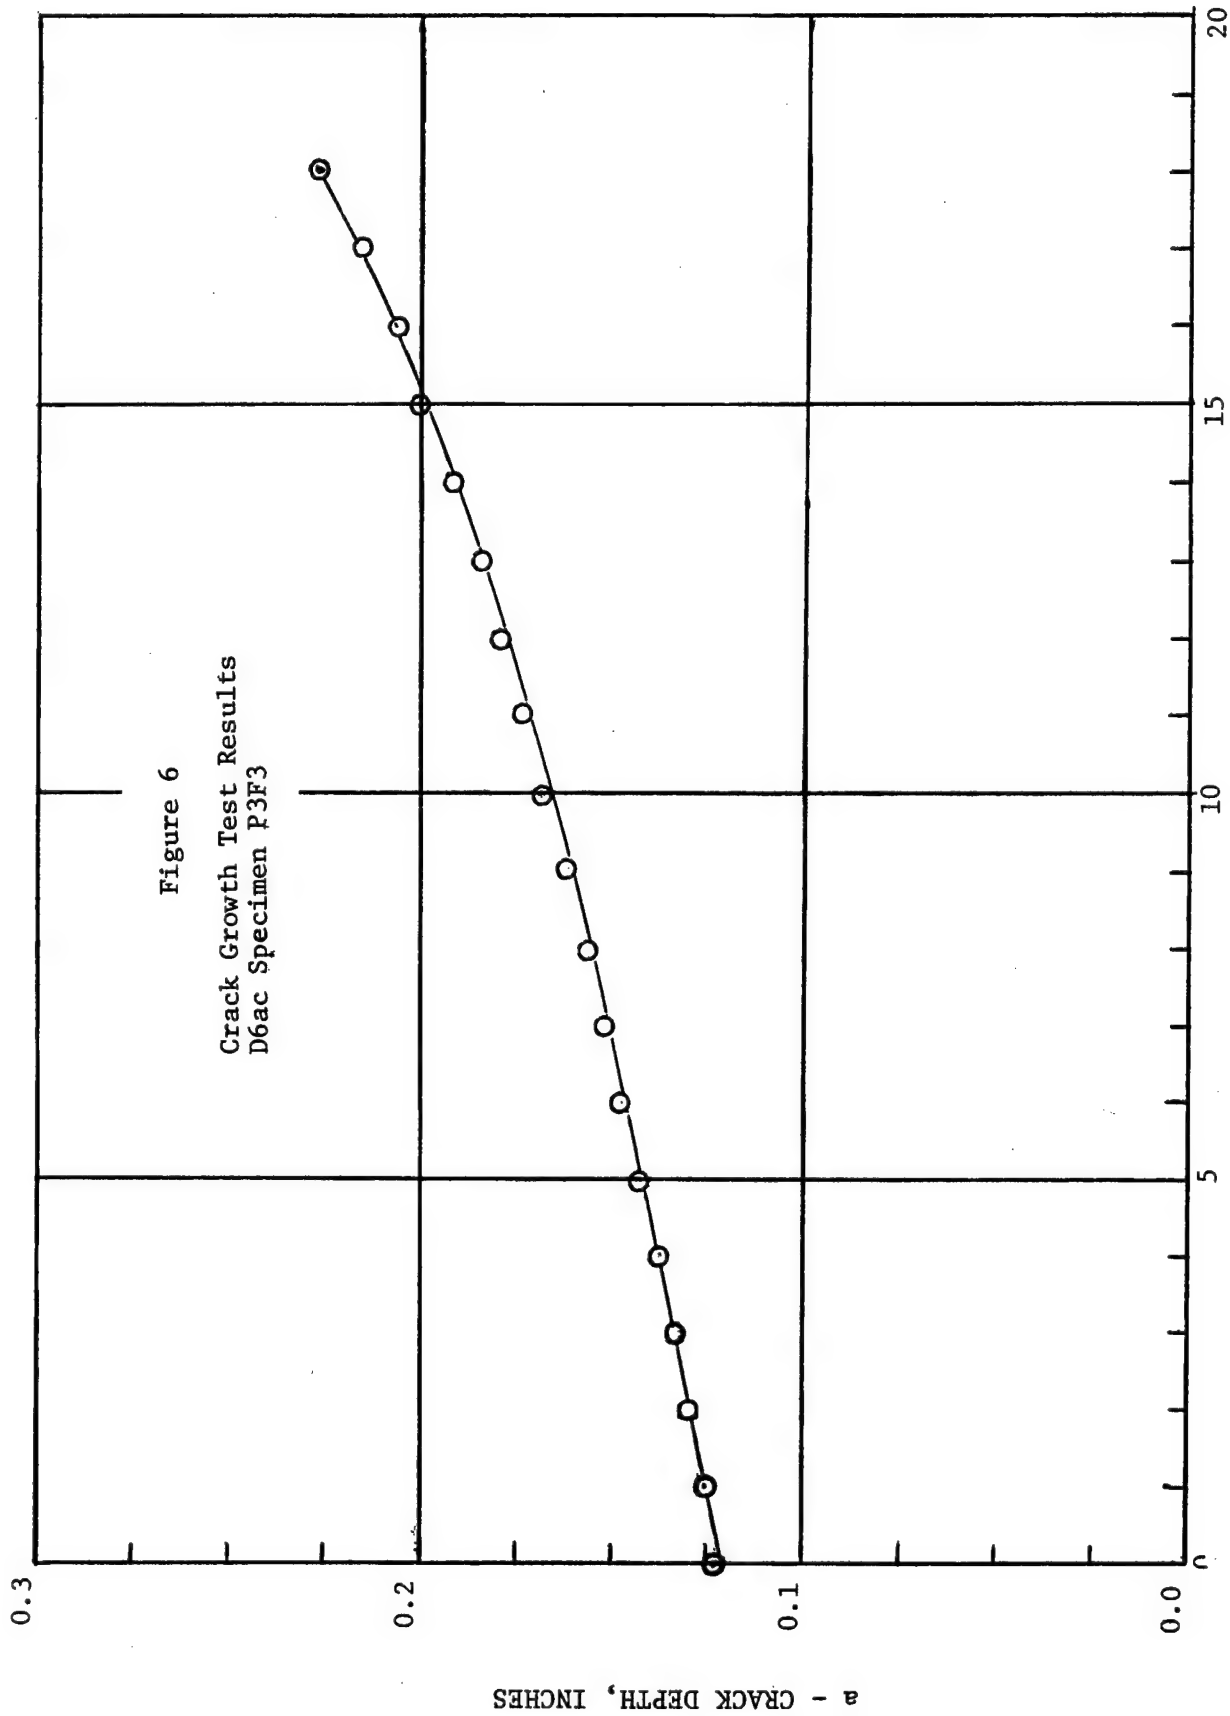
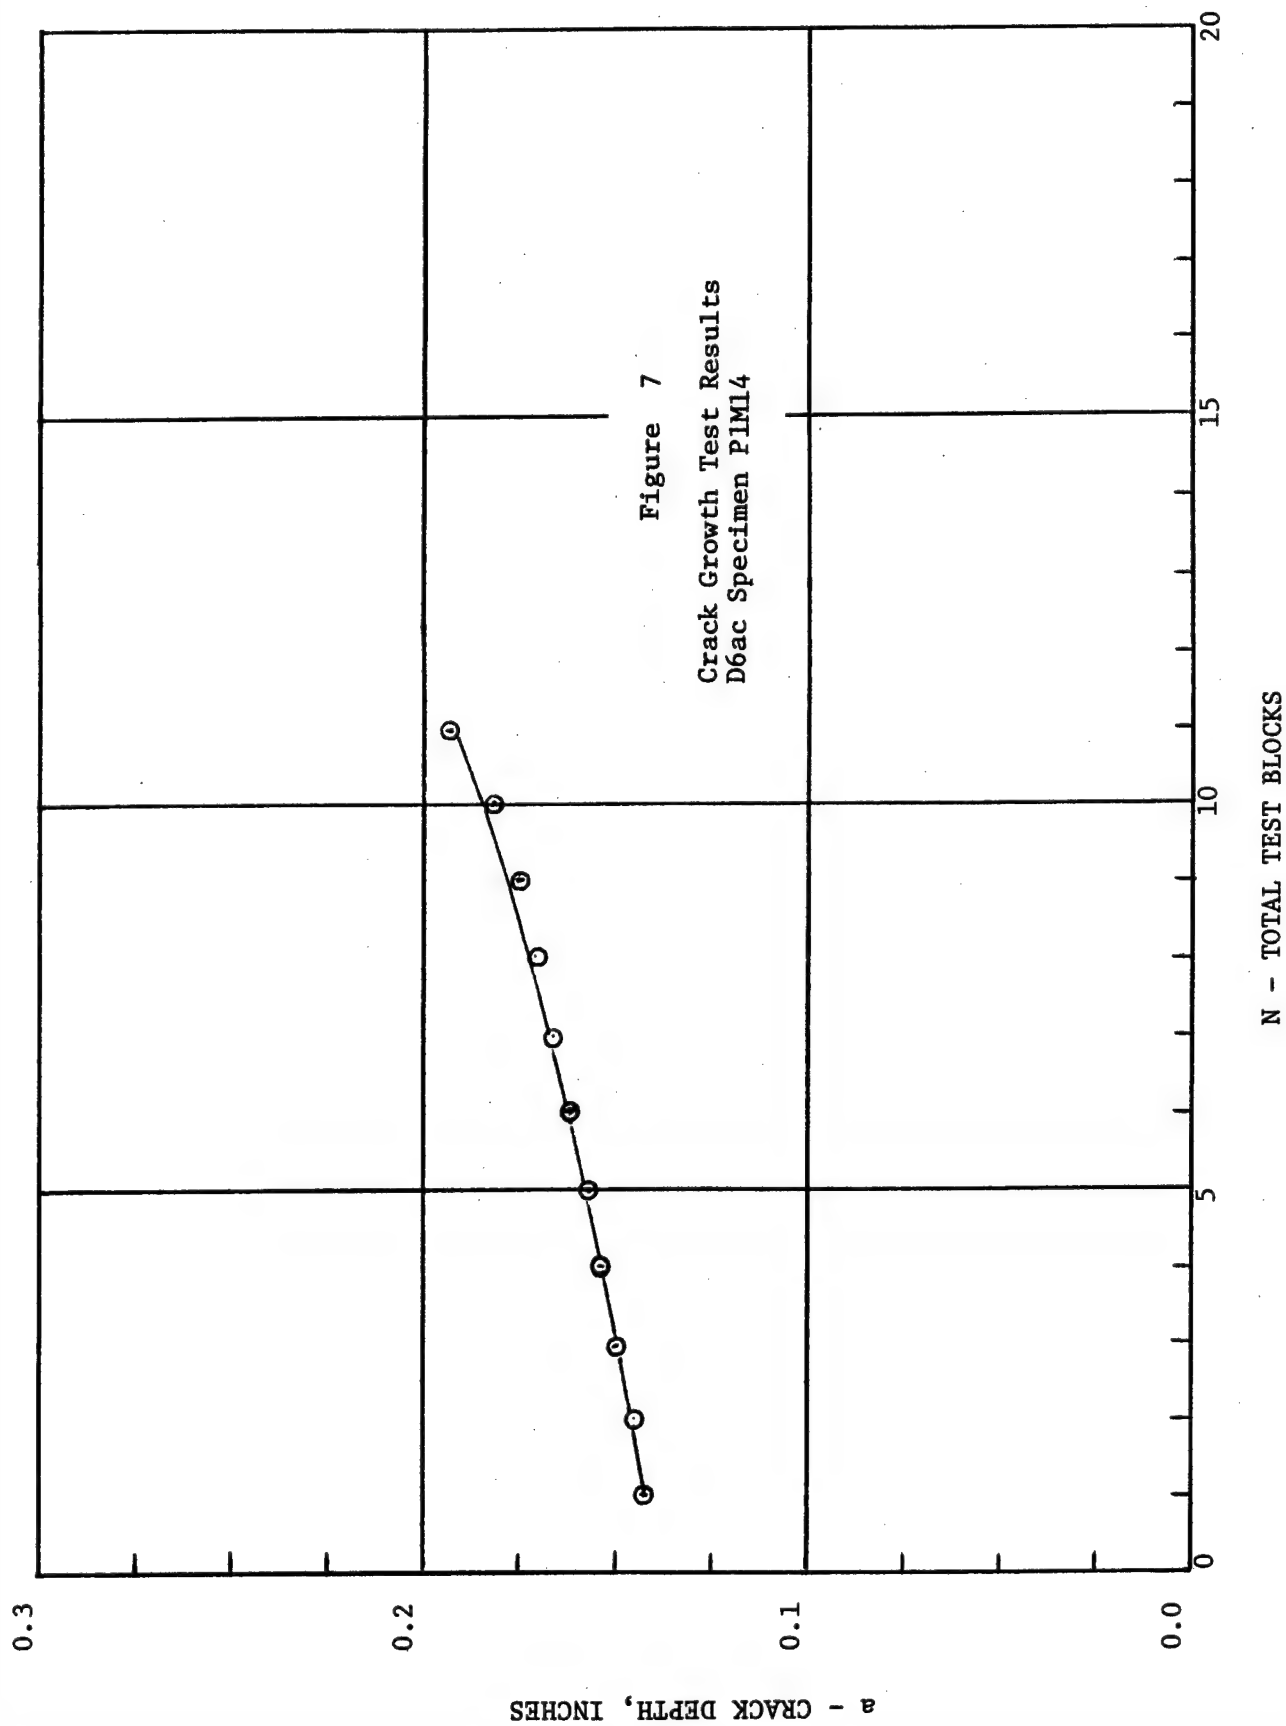
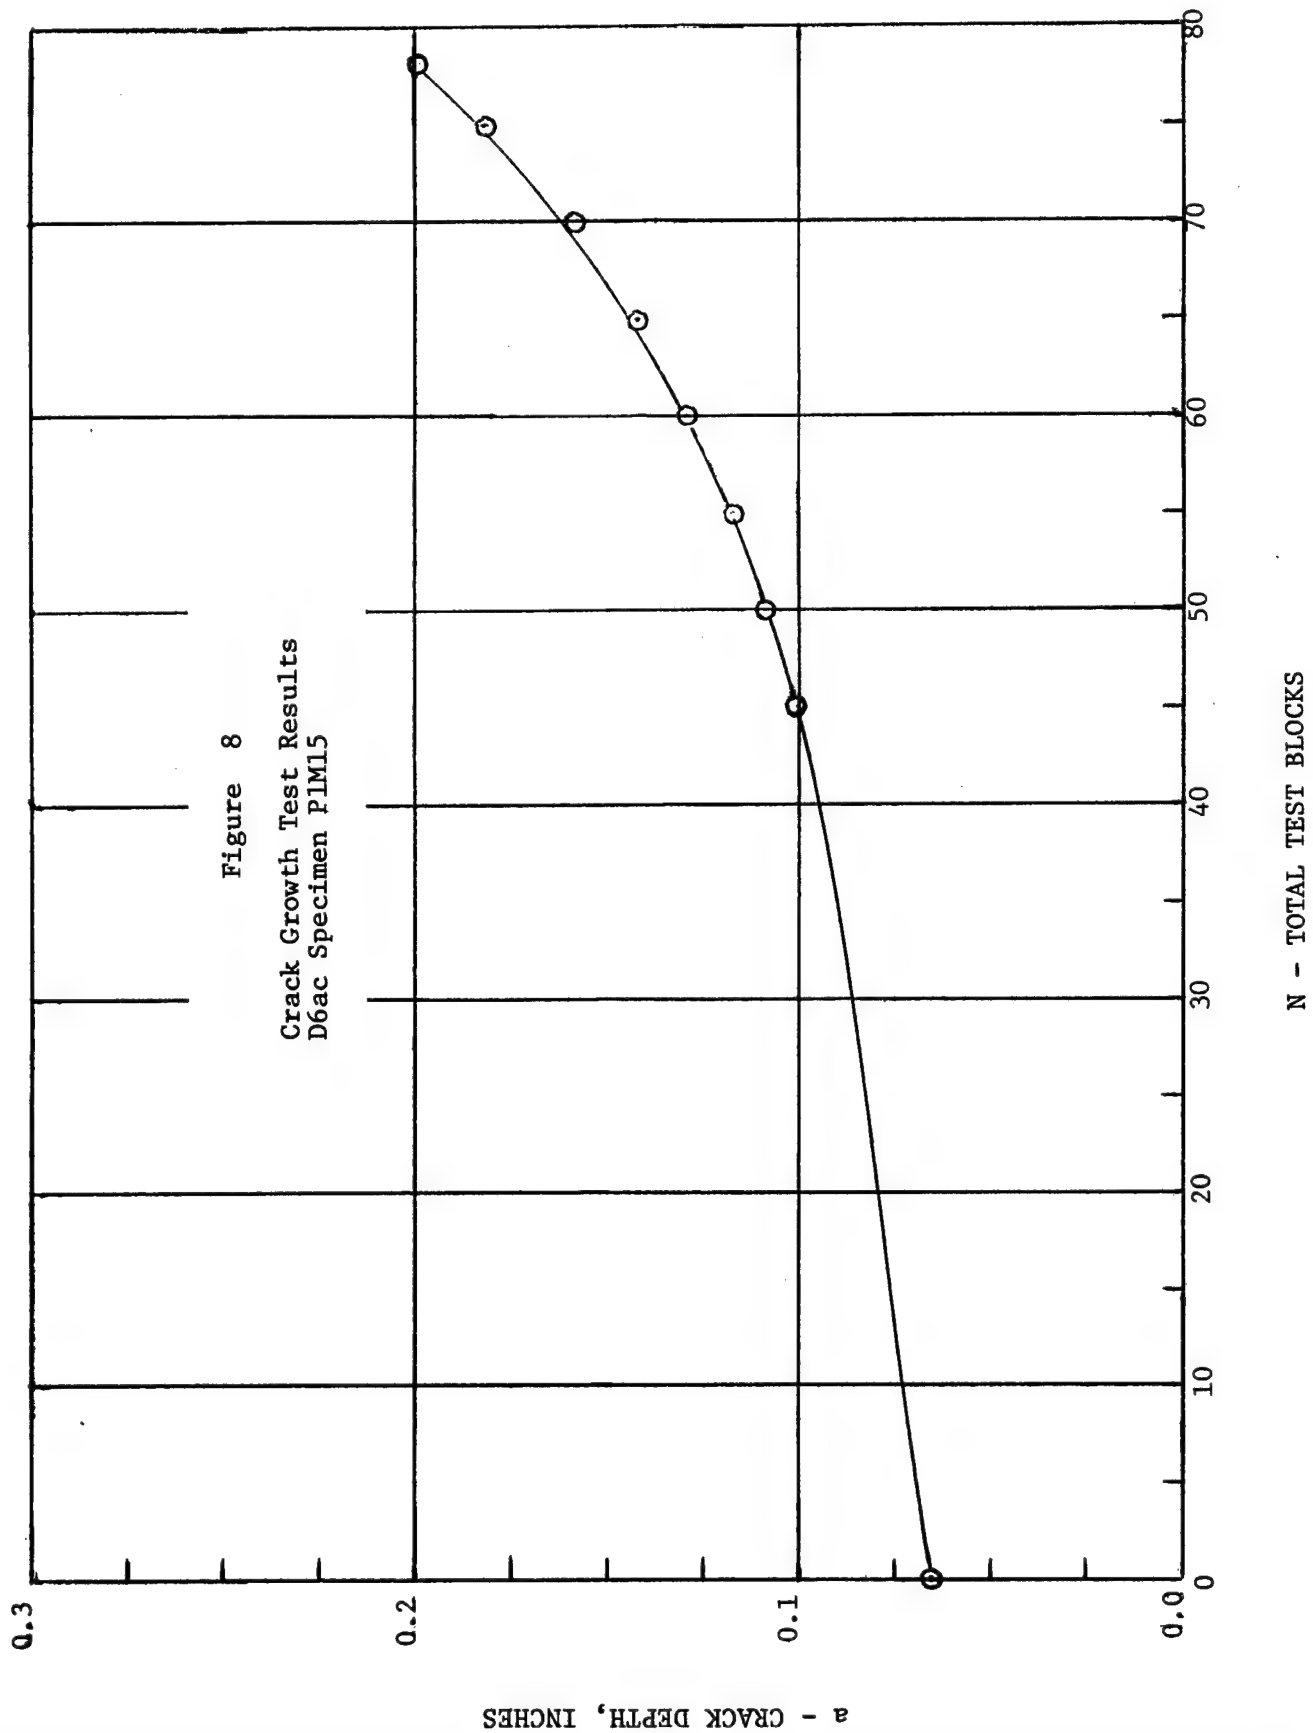
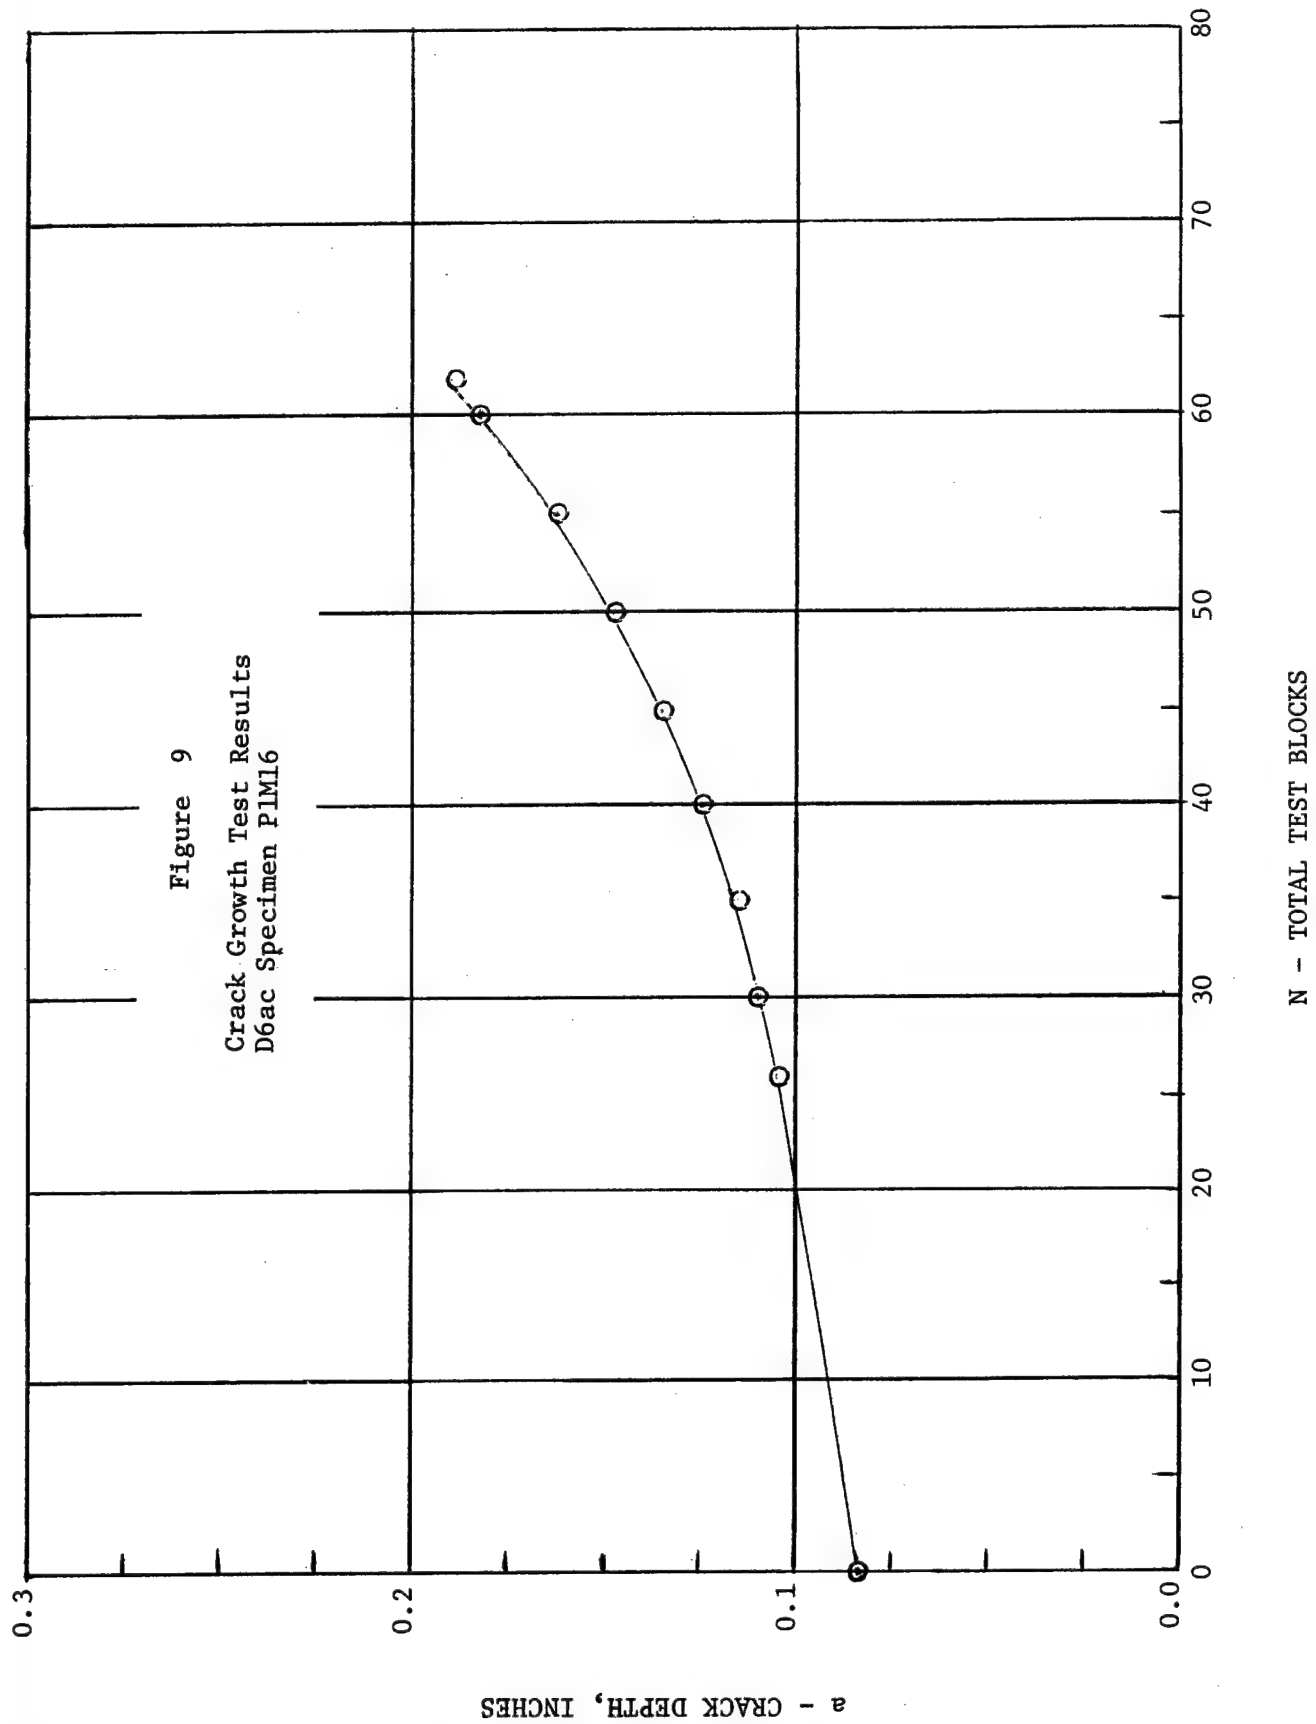
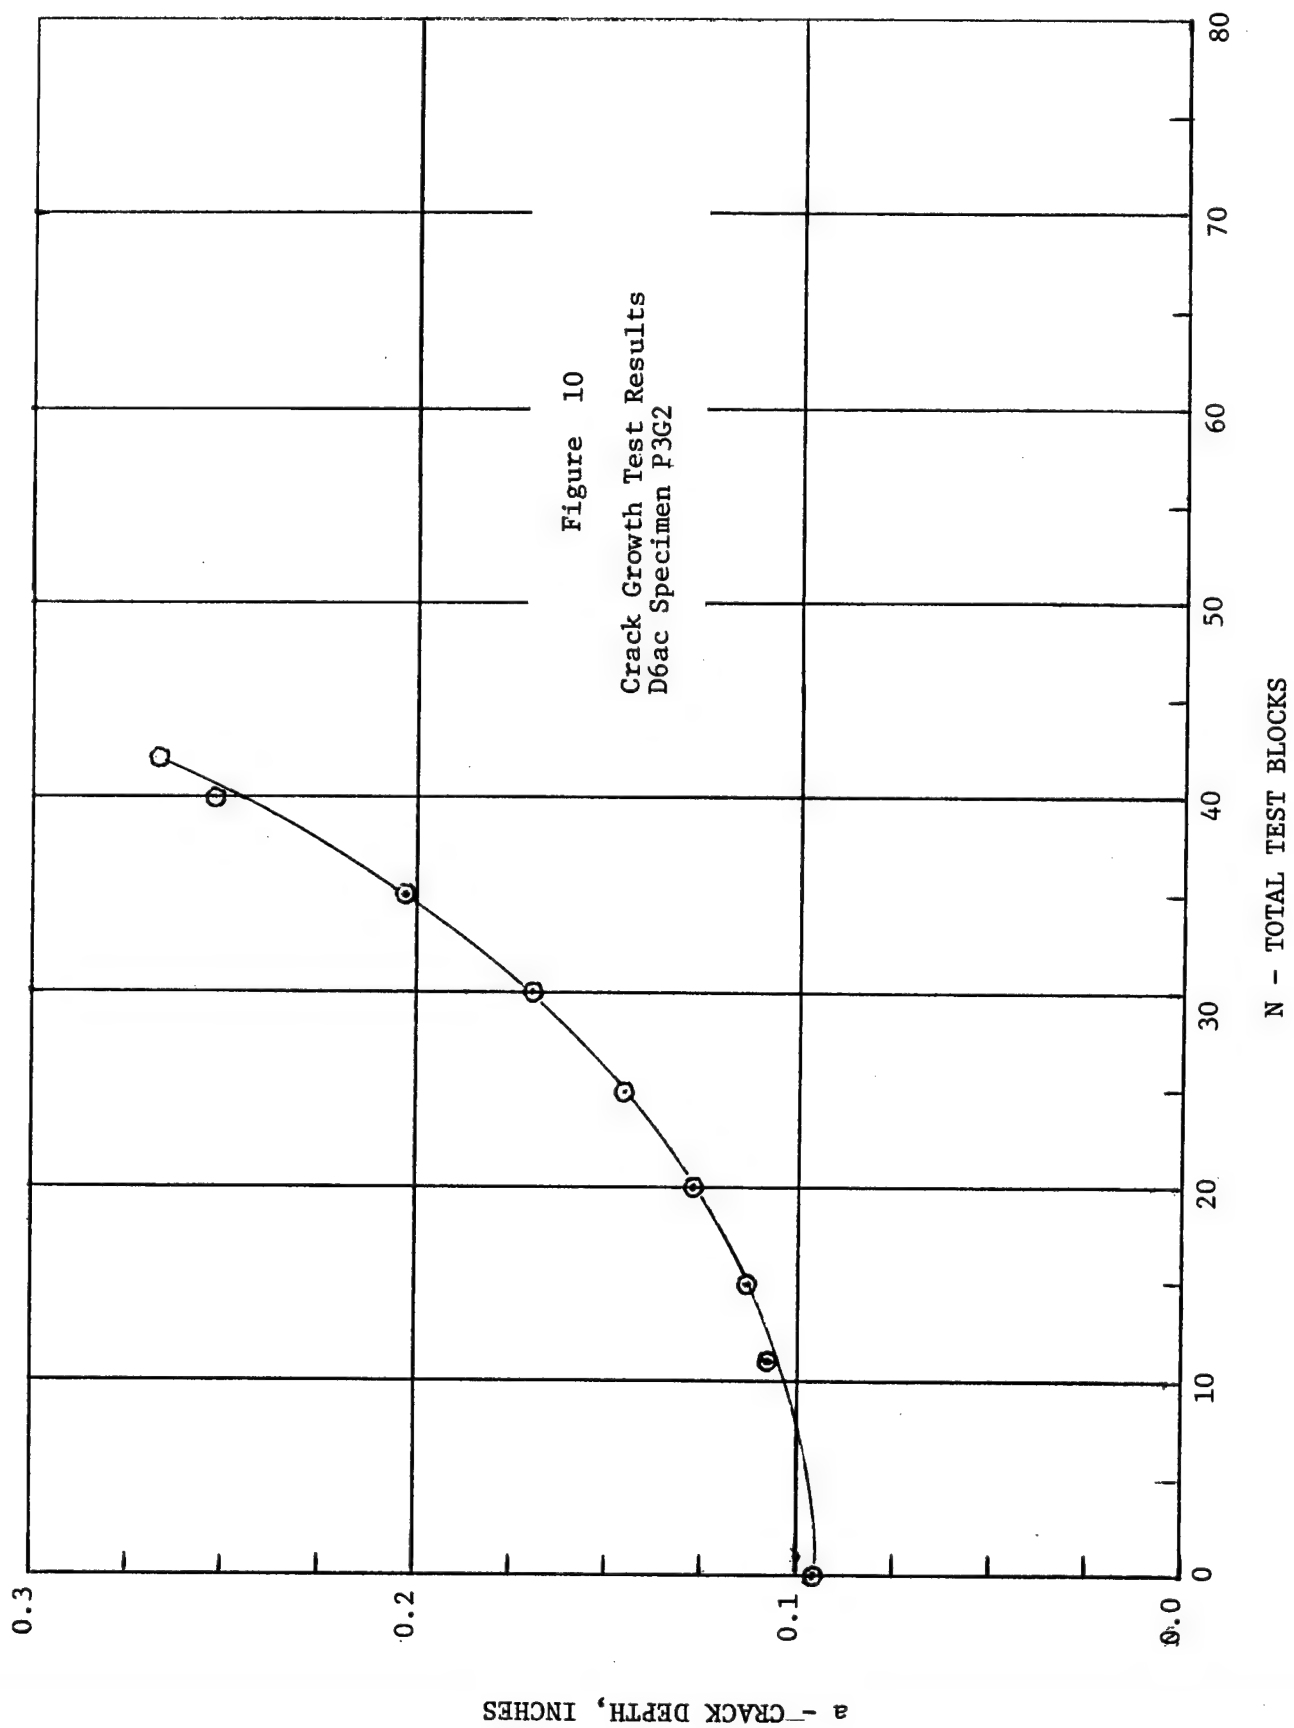
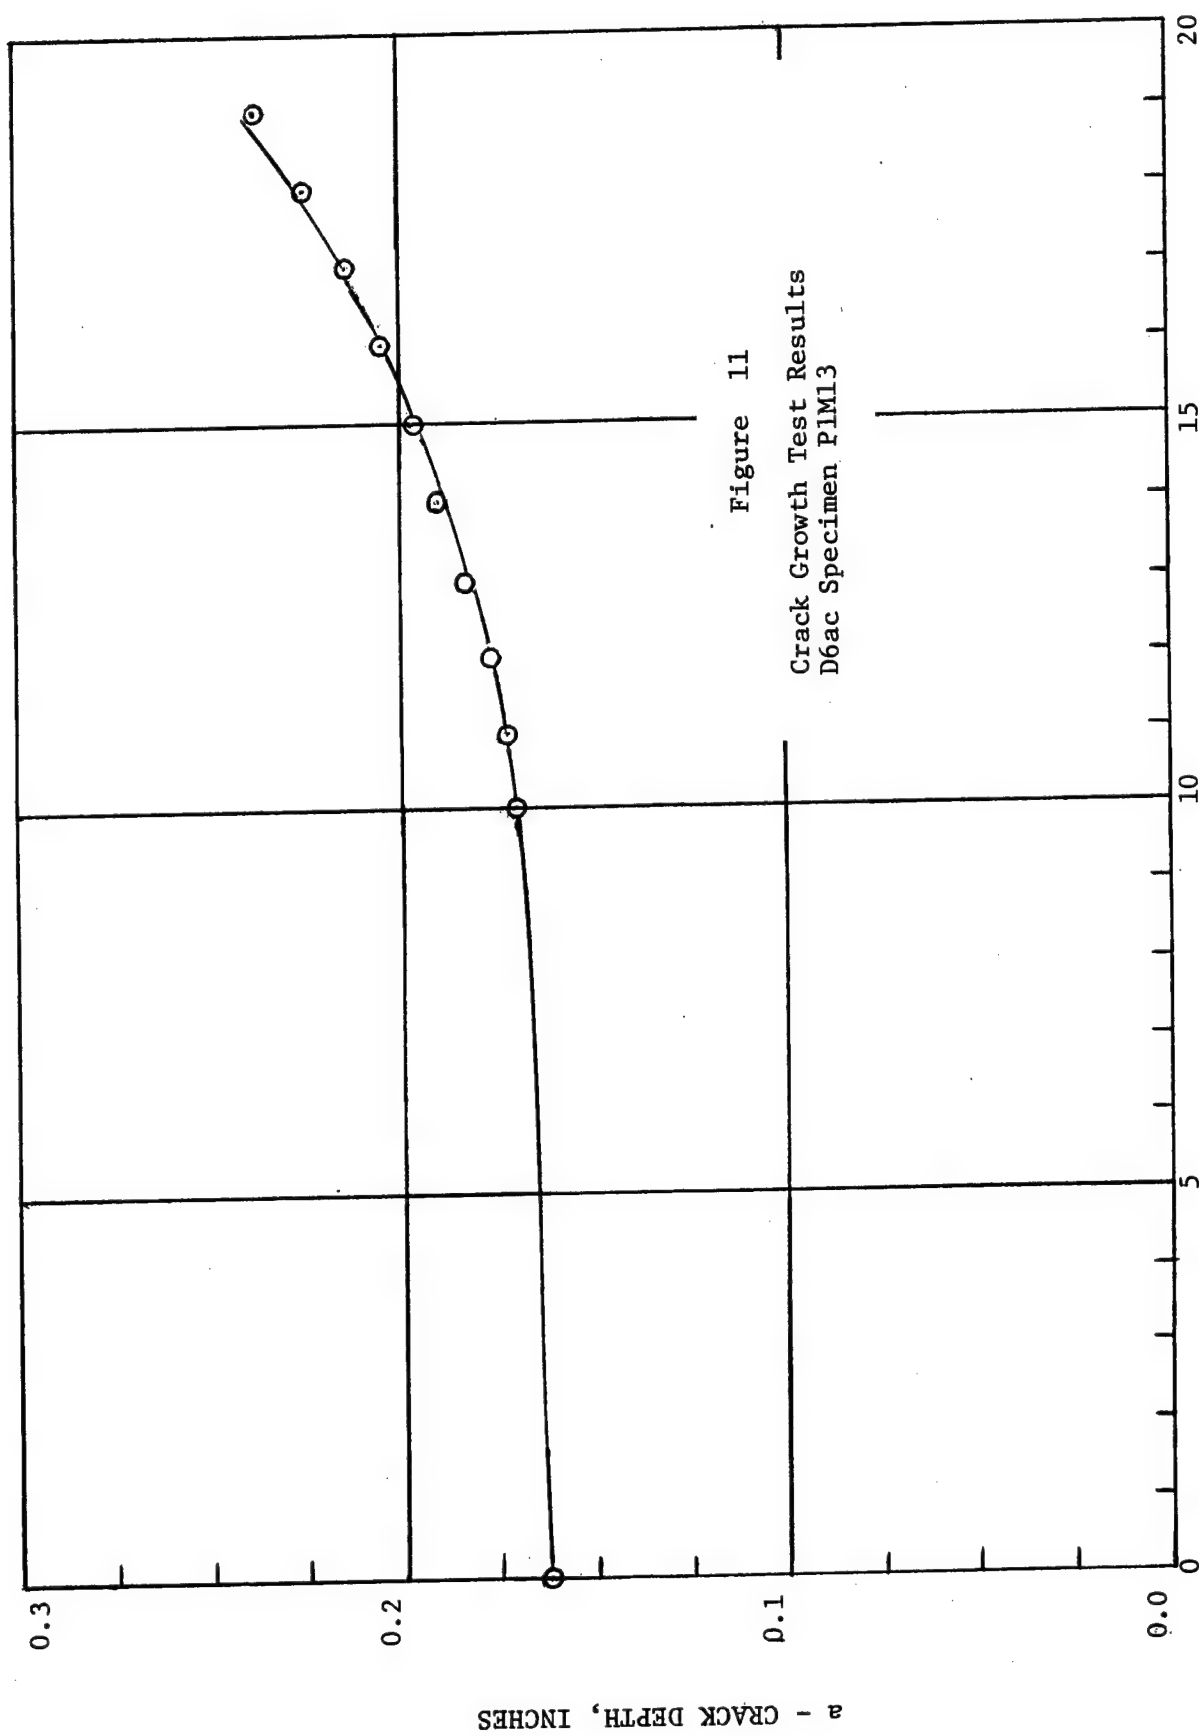
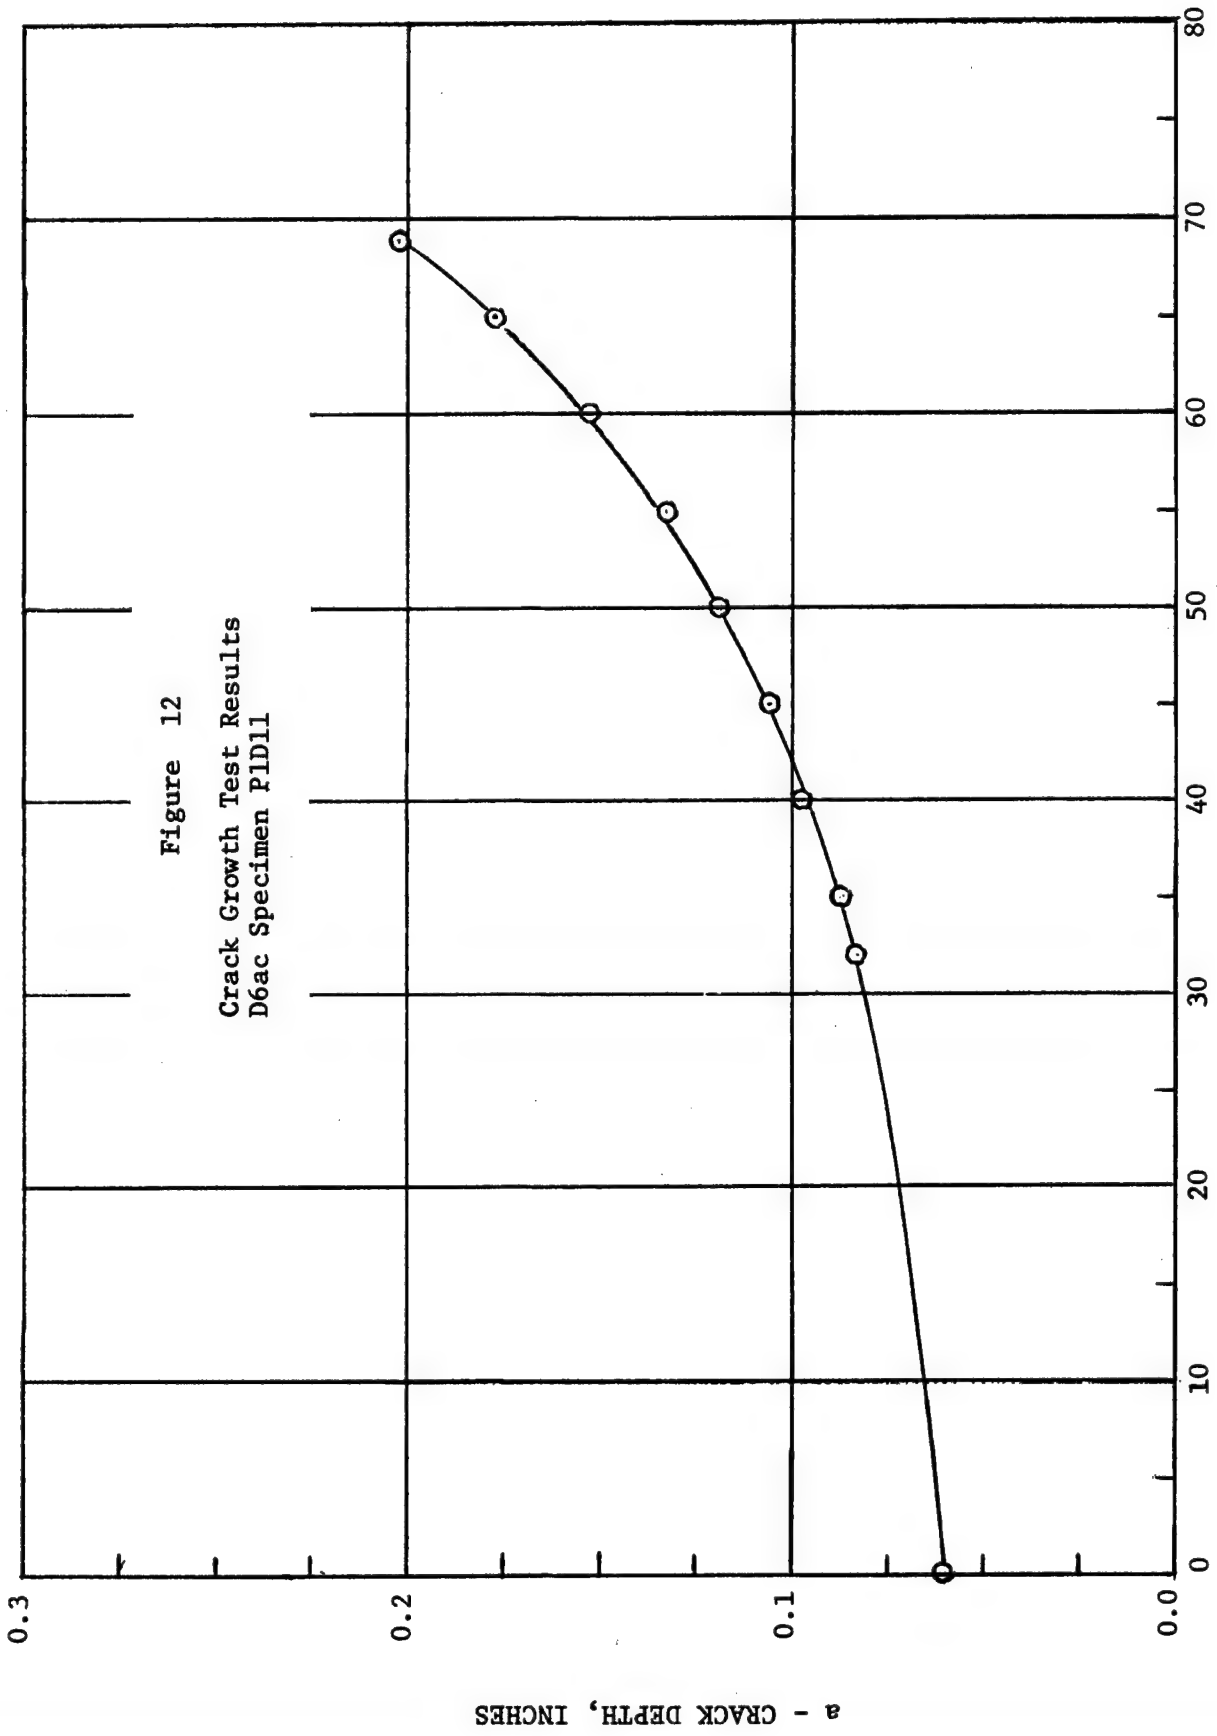
Table IV contains the measured crack depth "a" for individual blocks of testing. In all cases, this measurement was made from the specimen surface to the band produced by layer 30 of the spectra. Plots of this data are contained in Figures 5 through 20. Final fracture dimensions for each specimen are summarized in Table III. Table II contains a detailed summary of important test results and includes estimates of the stress intensity factor  $K_Q$  at the point of fracture.

N - TOTAL TEST BLOCKS

N - TOTAL TEST BLOCKS AFTER SECOND PROOF TEST

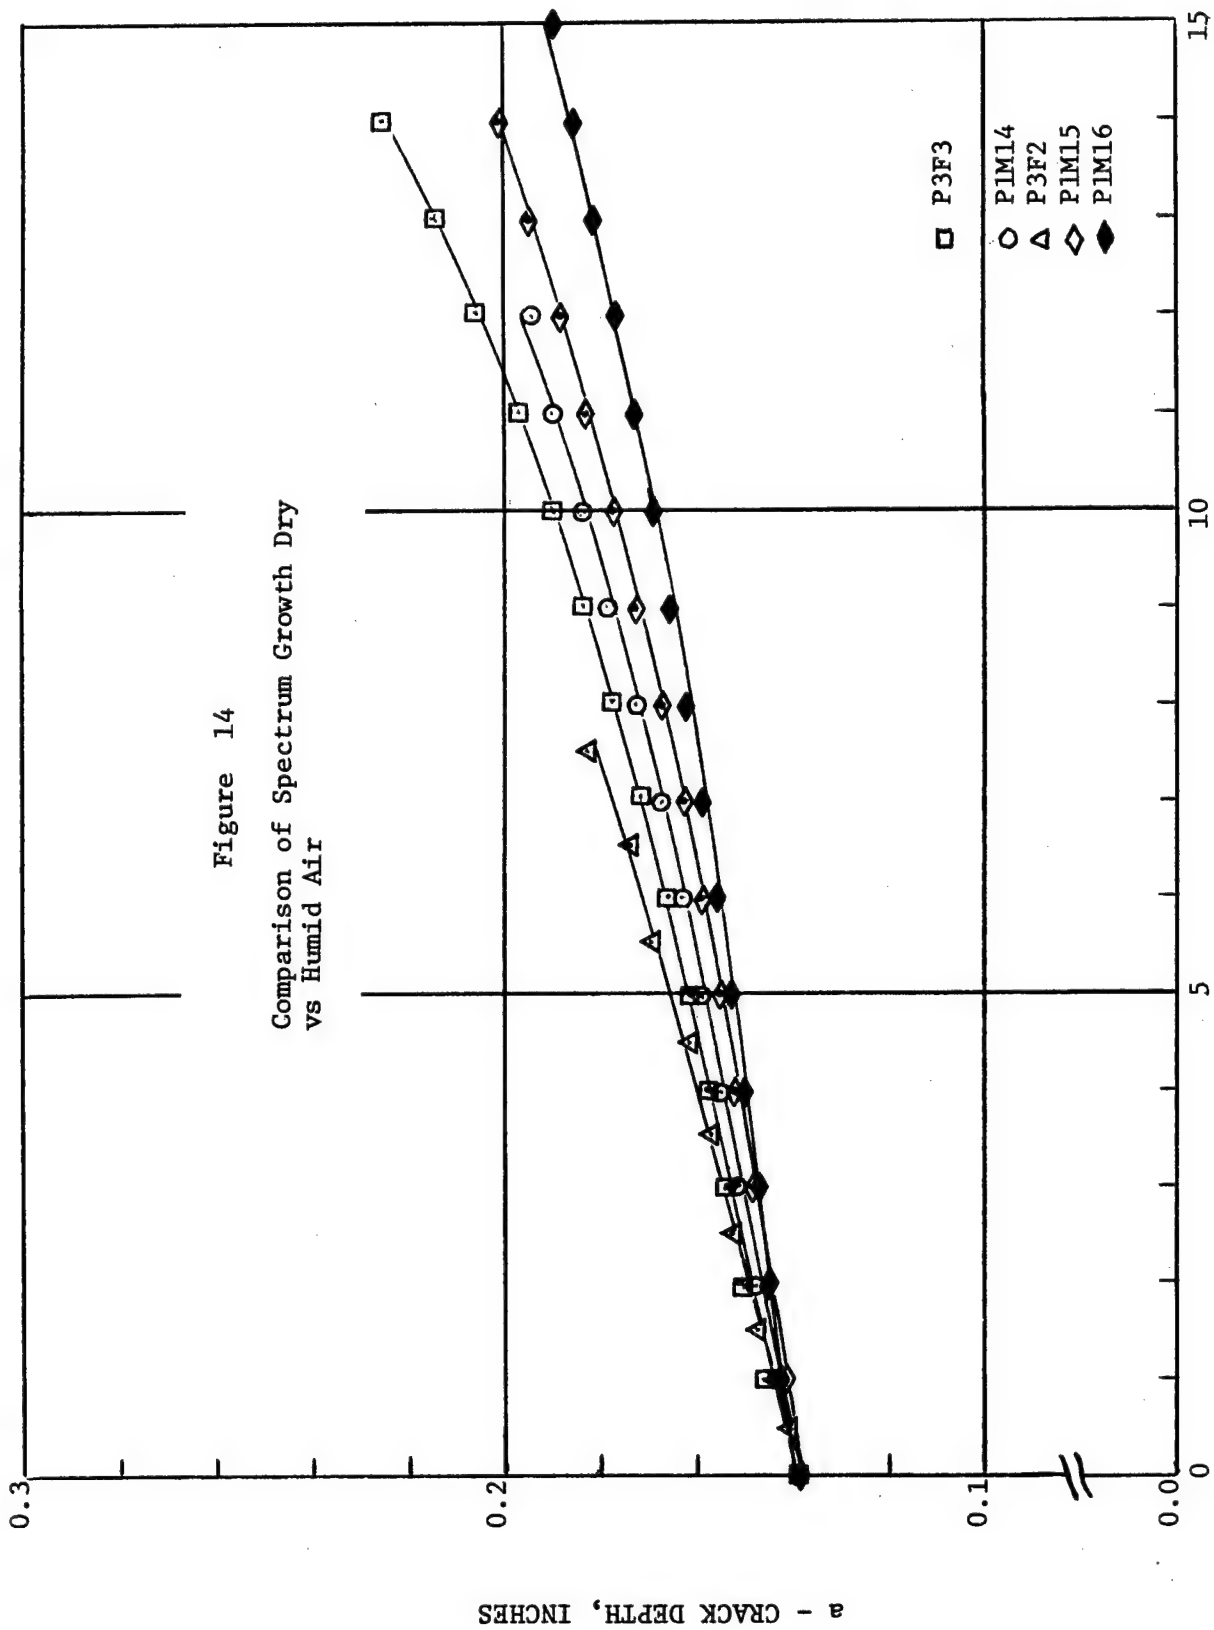
To indicate the variability of spectrum growth data, all non-proof tested 5g MAC spectrum data has been plotted in Figure 14. The data has been normalized to a common crack depth. The dry air data of specimen PLM16 has been included also to show the accelerating effects of humid laboratory air.
